# Case Study 16

## Hydraulic System Clean-up for Plastic Bottle Maker

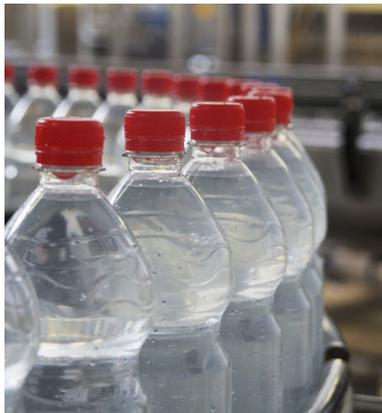
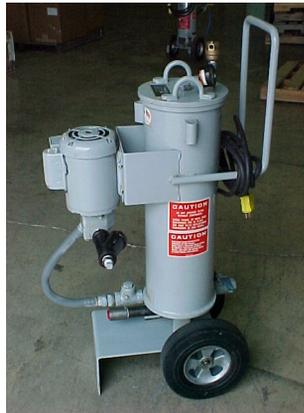
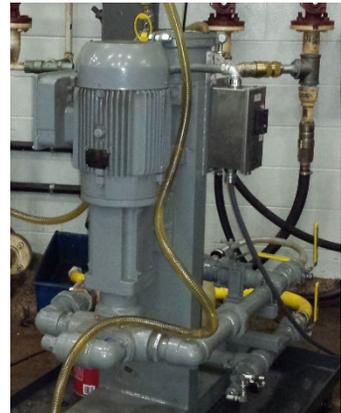
Our VAS staff performed particle count fluid analysis on three of the oldest machines with fluid drawn from the reservoirs. The test results indicated the fluid did not meet the required cleanliness for their systems. Further inspection of the reservoirs confirmed our suspicion that years of contamination ingress had resulted in a thick layer of silt inside the reservoir. Northeast Filter sold a portable filter system to be installed as a kidney loop on the reservoirs of their oldest machines and used on a rotational basis. After 30 days the fluid in each of the machines had improved to “like new” condition with greatly reduced OPEX. As a result, they decided to install dedicated stationary filter systems on every machine in the plant and now use the portable filter as a fluid transfer cart. Our VAS team also helped them establish a routine fluid condition monitoring program.
