# Case Study 17

## Engine Intake Emergency on Gulf Coast Tug

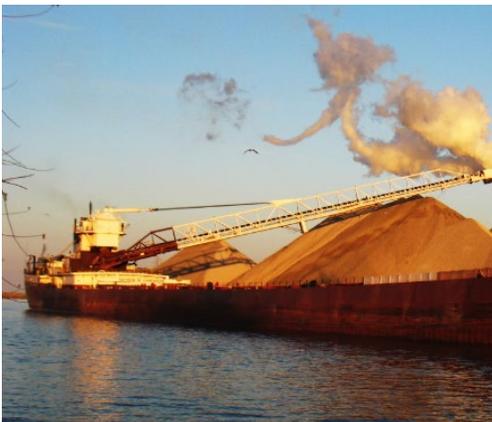
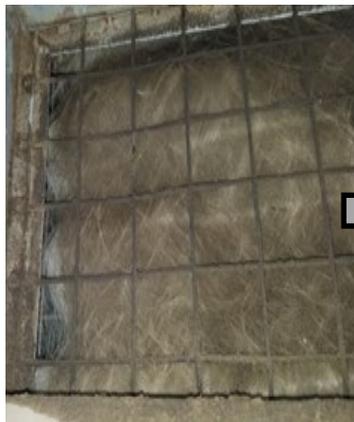
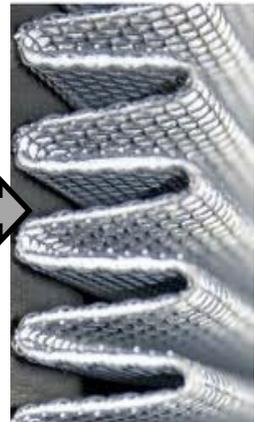
Once aboard the vessel, we saw firsthand just how bad the situation was. Particle analysis of the dust and fluid analysis of the engine oil showed that the highly abrasive alumina dust not only penetrated the engine room inlet air filters, but the engine intake filters as well. Both were using bulk fiberglass media effective at removing  $40\mu\text{M}$  particles however the particle size distribution of the alumina from the particle analysis indicated that the dust particles were between  $5\mu\text{M}$  -  $20\mu\text{M}$  with  $>60\%$  between  $5\mu\text{M}$  -  $7\mu\text{M}$ . Northeast Filter recommended heavy duty (washable) pleated synthetic filter panels with 99% retention efficiency at removing  $3\mu\text{M}$  particles to replace the bulk media. The filters were installed after the engines (and engine room) were overhauled and the ATB left port to deliver the cargo to the destination aluminum mill 30 days later with no further engine problems. Later that year, the rest of the fleet converted to these filter panels.
