Case Study 24

Steam Turbine Oil Mist Eliminator for Reservoir Vent

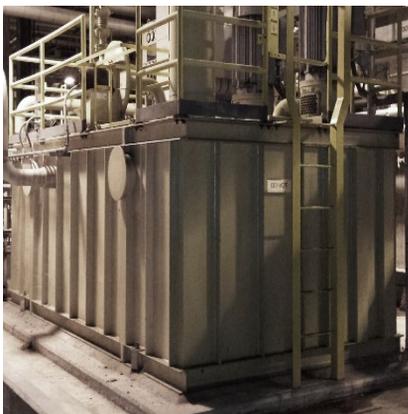
After touring the facility we observed that their steam turbine lube oil reservoir was vented through the top side of their building with a visible smoke. An old mesh style “vapor extractor” system was installed when the plant was built but is very difficult to access and has never been opened or changed. They showed us a spare mesh pad from their stores but were not sure how to change it without removing piping. We quoted a highly efficient, blower assisted oil mist eliminator system with synthetic coalescing elements sized for the turbine/reservoir and fully compliant with the Clean Air Act and RICE NESHAP. The blower ensures a constant negative pressure on the reservoir to avoid over pressure concerns with a built-in bypass and check valve in the event of system failure and to prevent back pressure. The oil collected is drained back to the reservoir to minimize oil loss. After the unit was installed the difference was apparent with no smoke visible at the outlet port. The building was cleaned immediately after installation, and it is still clean 6 years later!

Before Installation

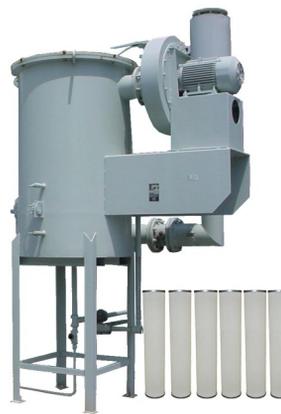
After Installation
