# Case Study 28

## Venting your Filter Housing

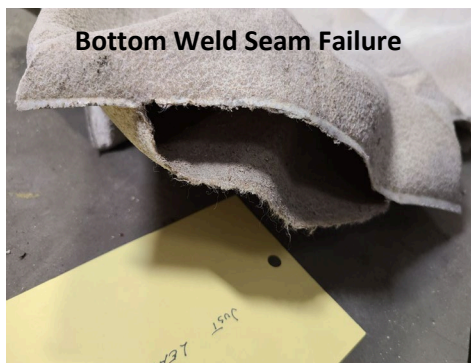
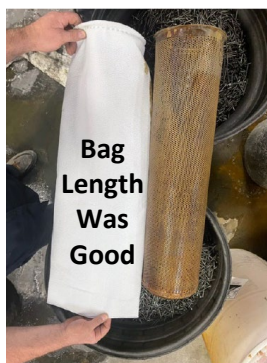
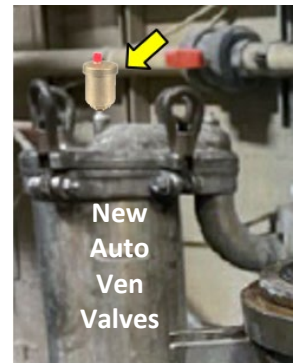
In western Ohio there is a full-service mechanical plating and galvanizing facility who were having issues with filter bags bursting. Failures of the filter bags were impossible to predict but in some cases were bursting at the seams 1-2 times per shift. Typically, the bottom of the filter bags is where they experienced most of their failures. Leading us to believe there could be an issue with the filter bags themselves. Failure of the filter bags meant containments going downstream causing a variety of issues. Initial concerns from Northeast filter were regarding the welded seam strength of the filters being used.

Northeast Filter arrived on site to provide inspections of the filter bags to determine what could be the root cause of these failures. Inspection included observation of the filter bags themselves, filter basket removal from the housing (to verify bag length/fit), and finally analysis of the filter housing and operational procedures. The first action to be taken was replacement of the filter bags with a new manufacturer who provided better quality weld seams. Another concern was the partial coloration of the used filter bags. The bags had visual discoloration on only the bottom half of the media. This indicated the housing was not being properly vented causing an air lock (bubble) in the top of the housing. After consultation with the customer, they purchased automatic vent valves for each housing allowing air to completely displace the liquid in the housings. Upon follow up the customer has increased their life exponentially and are changing filters a couple of times a week instead of 1-2 times per shift. The issue with weld seam failure has been completely eliminated.
