# Case Study 35

## Proper Operation and Maintenance of Bag Filters

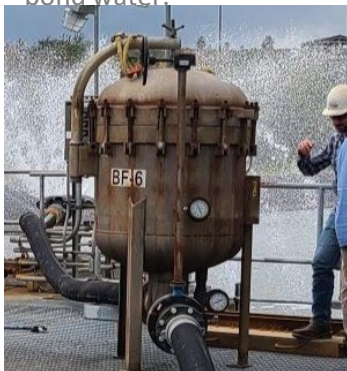
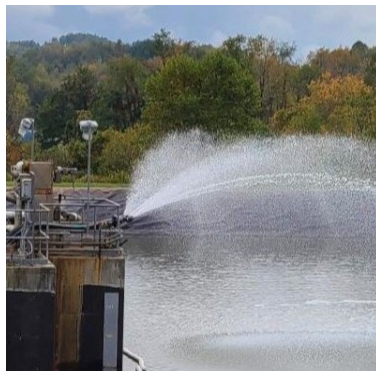
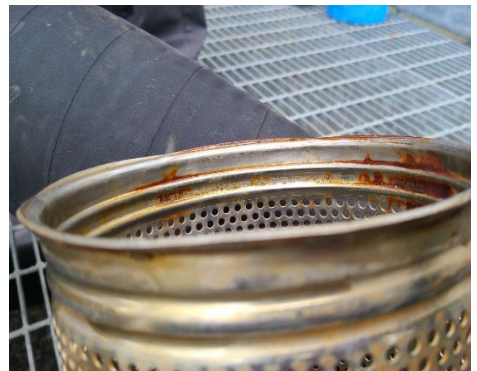
When Northeast Filter arrived at the plant to review the filter equipment and operation of the system. It was noted that the filter housing was not in the best condition due to its age. The retaining baskets that were meant to position and seal the bags were in poor condition leading the customer to attempt to seal the bags with an RTV Sealant and rely on expensive multilayer bags to affect a seal between the baskets and top plate of the vessel. Additionally, it was pointed out by NFC that the housing lid was improperly indexed leading to a misalignment of the bag filters and the housing lid causing flow restrictions and a by-pass condition. NFC helped the customer properly index the housing lid onto the housing and assisted in replacing new bag filters to create an adequate seal. Upon testing of the filter system and sampling of the filtered effluent, turbidity measurement requirements were surpassed for safe discharge. NFC also recommended the replacement of the filter baskets with new ones which would provide for a positive seal with standard filter bag tops. The customer has made these upgrades and has been able to save money on replacement bag filters while meeting cleanliness standards while safely discharging the filtered pond water.
