Case Study 18

Water Contamination in Steam Turbine Lube Oil

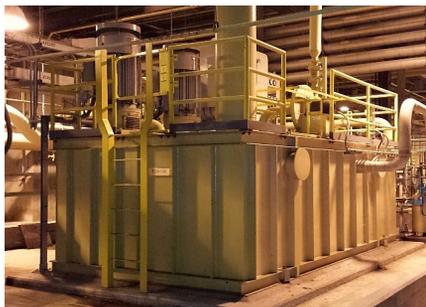
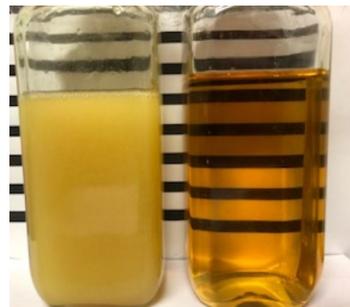
When the VAS team arrived, the plant had already drained most of the settled free water out of the reservoir, but the oil was still milky. Fluid analysis showed their Chevron GST-32 lube oil had 5% moisture content. GST-32 is specifically formulated for steam turbine conditions and exhibits excellent water separability with minimal foaming making it an ideal candidate for coalescing. A 2-gallon sample was processed through a benchtop coalescer with exceptional results bringing the water content down to 109 ppm (by ASTM-1744 Karl Fischer) on a single pass through the coalescer. NFC provided a rental coalescing system to use until the actual unit they purchased arrived. The high flow rate of the coalescer quickly removed the water to bring the oil to like new condition preventing any system damage by limiting water exposure to a short period of time. The turbine started up without issue and the coalescing system has run flawlessly ever since!
